DEPARTMENT OF TRANSPORTATION

Quality Assurance and Source Inspection

Contract #: 04-0120F4Cty: SF/ALA Rte: 80 PM: 13.2/13.9File #: 69.28**WELDING INSPECTION REPORT****Resident Engineer:**Pursell, Gary**Address:** 333 Burma Road**City:** Oakland, CA 94607**Report No:** WIR-016346**Date Inspected:** 08-Aug-2010**Project Name:** SAS Superstructure**OSM Arrival Time:** 700**Prime Contractor:** American Bridge/Fluor Enterprises, a JV**OSM Departure Time:** 1900**Contractor:** Zhenhua Port Machinery Company, Ltd (ZPMC), Changxing Island **Location:** Shanghai, China**CWI Name:** Mr.Qiu Wen**CWI Present:** Yes No**Inspected CWI report:** Yes No N/A**Rod Oven in Use:** Yes No N/A**Electrode to specification:** Yes No N/A**Weld Procedures Followed:** Yes No N/A**Qualified Welders:** Yes No N/A**Verified Joint Fit-up:** Yes No N/A**Approved Drawings:** Yes No N/A**Approved WPS:** Yes No N/A**Delayed / Cancelled:** Yes No N/A**Bridge No:** 34-0006**Component:** Tower and Orthotropic Box Girder (OBG)**Summary of Items Observed:**

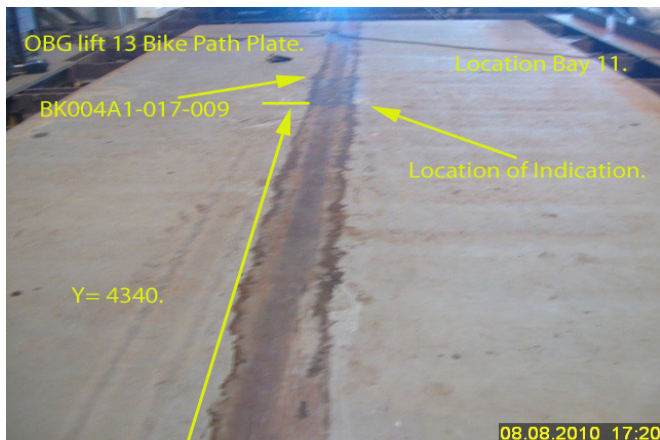
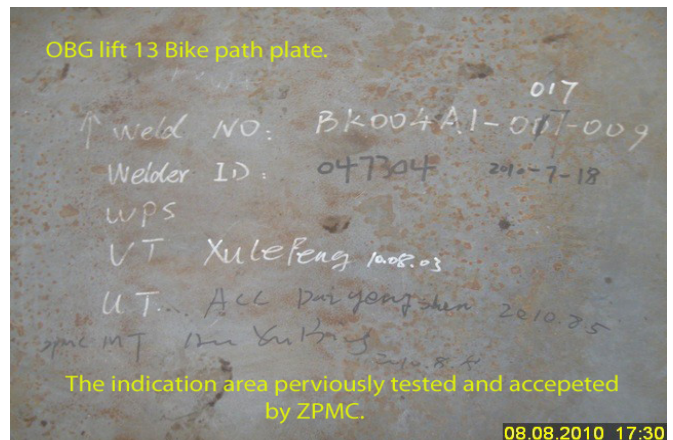
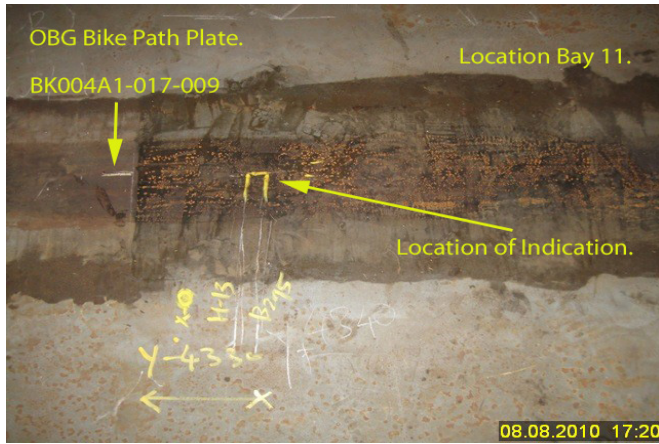
During random 10% verification Ultrasonic Testing (UT) of OBG Lift 13 Bike path plate, this Quality Assurance Inspector (QA) discovered the following issue: One (1) Class "A", non conforming longitudinal indication measuring approximately 25 mm in length. The weld is identified as BK004A1-017-009; complete joint penetration (CJP) Butt joint. OBG lift 13 Bike path plate. The discontinuity rating is observed as +10, Class "A" reject. The discontinuity is oriented at the Depth approximately 13mm from face A; Y location measured 4340mm (Y location is measured from nearest end of weld joint). X location measured 0 mm. The Material thickness is 16 mm. The member is NON SPCM (Non Seismic Performance Critical Member). The member is located in fabrication Bay 11. The indication is in an area previously tested and accepted by ZPMC QC. The Notice of Witness Inspection Number (NWIT) is 06361. For further information, please see the attached pictures below. This QA inspector generated incident report for this date.
